Citizen Road Condition Survey and Monitoring Project 2010 Accomplishment Report

**Olympic Forest Coalition
in collaboration with
Olympic National Forest
and
Great Old Broads for Wilderness Polly
Dyer/Cascadia Broadband**

Prepared by Shelley Spalding
January 2011

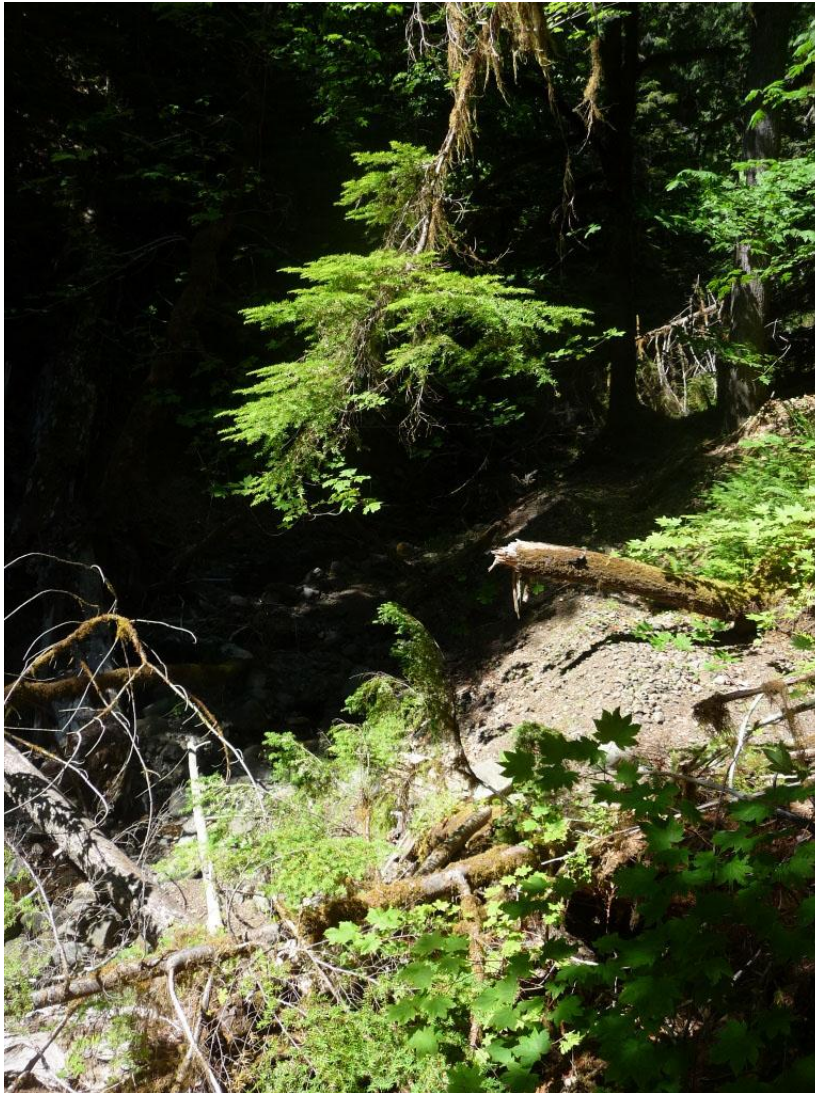
2353140.2 (Figure 4, Appendix B)

The FS 2353000 road was closed about a mile before the junction with the 2353140 road. The 2353140 began as an obvious road bed with numerous young alders growing in it. After about 0.5 miles, the road disappeared at a point where it would have dropped down to a creek. Surveyors continued looking for the road along the creek until they reached a steep waterfall and steep slope. When returning along the creek the surveyors noted evidence of extreme high flows with gravel deposited well above the creek bed.

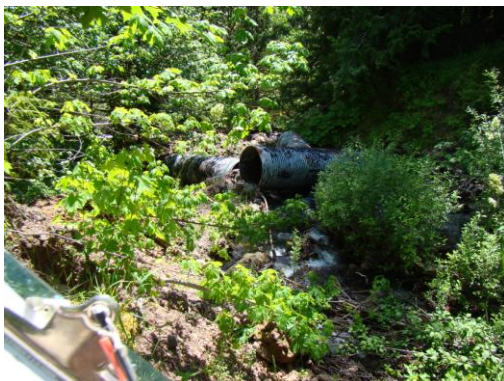
Road 2355000.3 (Figure 5, Appendix B)

This abandoned road is used by hikers to access the Wonder Mountain Wilderness.

Numerous washed-out or otherwise non-functional culverts were located on this road. At one site there were three culverts that intersected with the main creek and a fourth culvert that paralleled the creek, resulting in active erosion in some areas.

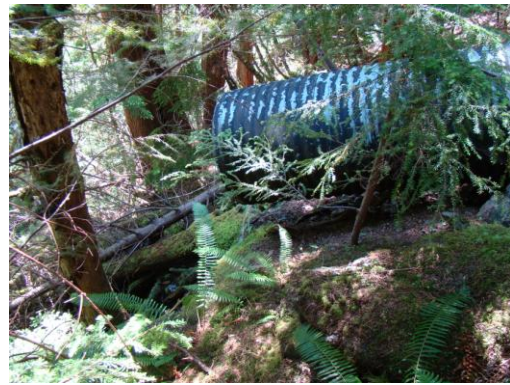
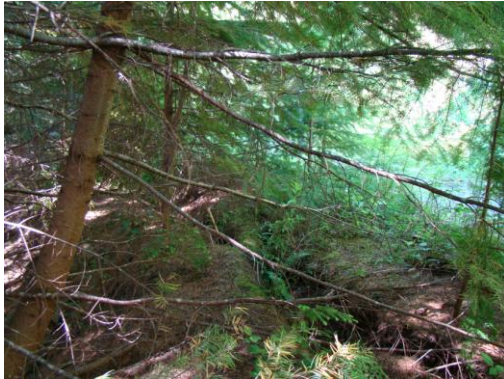
Although there was a small creeklet flowing through this culvert and no active erosion, the downhill section of the culvert was separated from the road portion by a three foot gap.

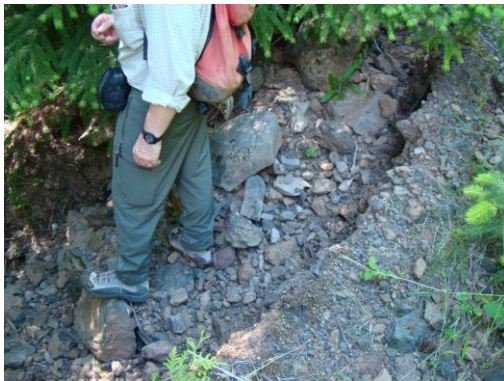
At several locations on this road there was evidence of road sidecast failure or tension cracks.

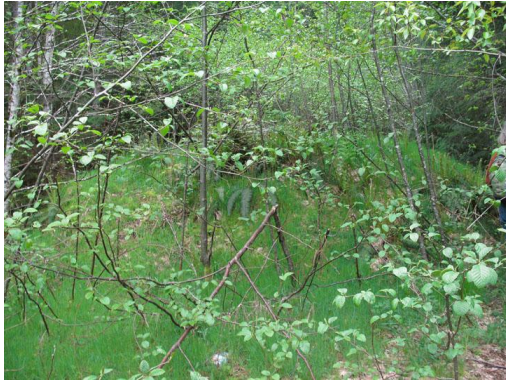
Road 2356000.10 (Figure 6, Appendix B)

There was a campfire ring located at the junction of the 2356000 and the 2356100, but the berm at the beginning of this road was well concealed by the vegetation that had grown up over nearly 20 years – mostly young alders and sword ferns. There was no sign of any kind of human use of the decommissioned road.

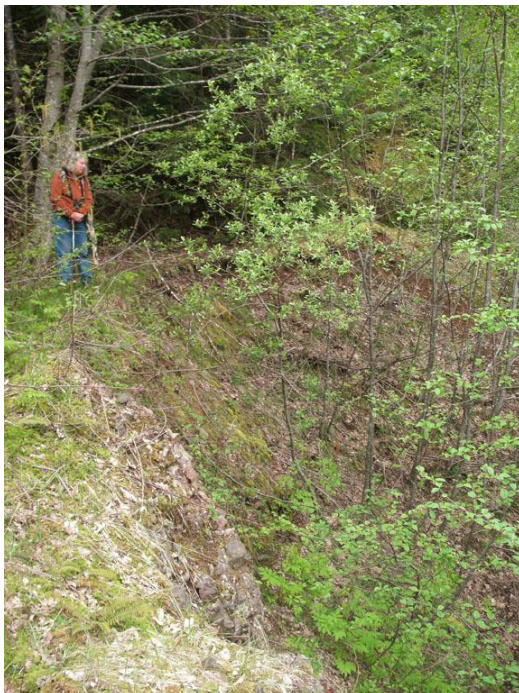
Western white pine (*Pinus monticola*) and western red cedar (*Thuja plicata*) were planted in sections of the roadbed at the time of decommissioning.

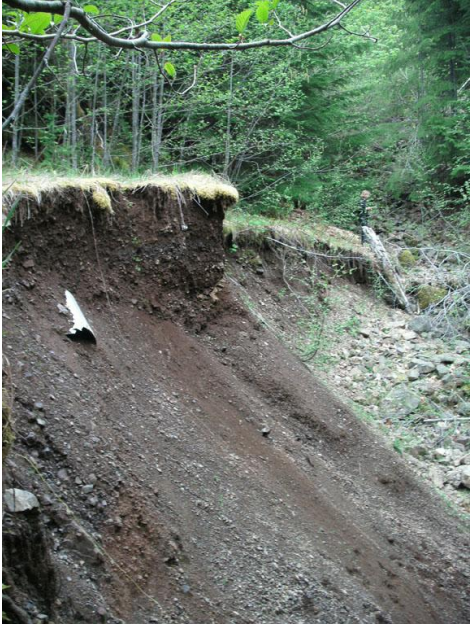
In the approximately one mile of road surveyed there were two stream crossings. Several sizeable slope failures were documented that were no longer active. Ten plus year old alders had colonized the steep ground at several of these sites.
